Aviation Safety

Maintainer

Issue 2/2000

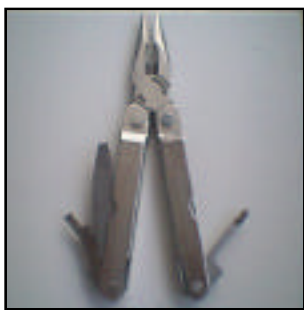
Saved by a Leatherman Tool!

The following is the first-person account of a U.S. Forest Service employee who was a passenger in a Hiller 12E helicopter on February 13, 1997, when the collective control linkage became disconnected at the rotor hub and the aircraft started an uncontrollable climb. The Forest Service employee/passenger climbed out of the airborne helicopter and managed to reconnect the linkage using the awl of a Leatherman tool, then held the makeshift repair in place until the chopper could land safely. Incredible, but true! The linkage bolt was located by the pilot immediately after the emergency landing; it had fallen into the engine pan, but the nut that went into the bolt was missing.

Since this story was widely published at the time, I will deal mainly with the drama of the event and human factors that could relate to the maintenance of any aircraft or helicopter. The first question that comes to mind is why the bolt came out of a vital control link. The answer is that a locking device was lacking. Either the safety device was faulty or it had not been installed during maintenance. This is the maintenance part of the story; now for the drama as described by the crew during the emergency.
